LPC# 0430305282--DuPage County  
Downers Grove/Ellsworth Industrial Park  
ILN 000508246  
SF/HRS

# CERCLA

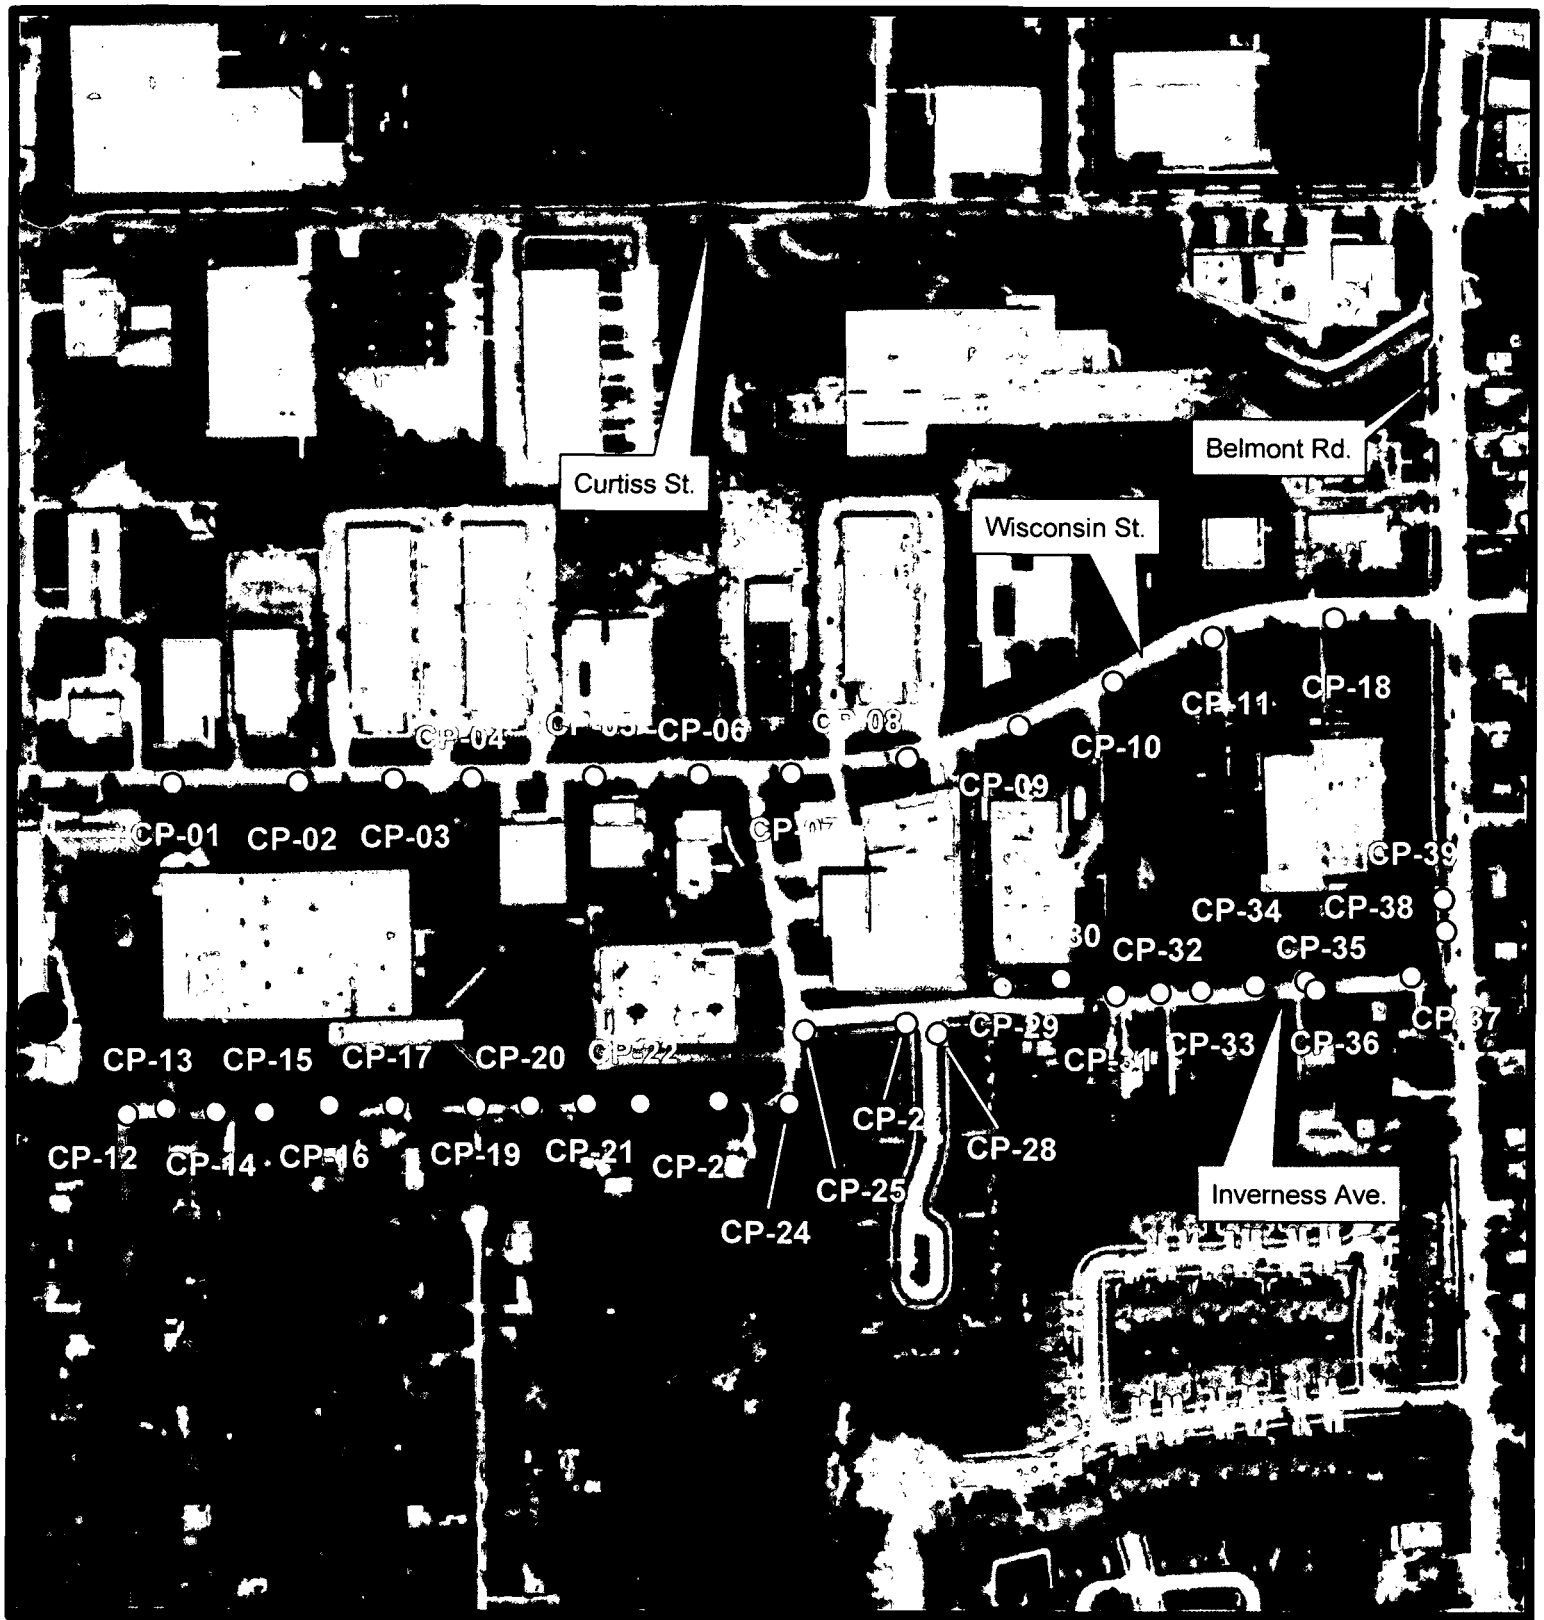
**FIGURE - 4**  
**IEPA OCTOBER 2001 CPT INVESTIGATION**  
**ELLSWORTH INDUSTRIAL PARK**

○ CPT Location

information of the EIP and to obtain groundwater samples, if possible, to identify possible source areas. CPT procedures are discussed in Section 3.3.1. Thirty-one (31) groundwater samples were collected from the 35 CPT locations. Eight (8) groundwater samples from seven (7) locations contained chlorinated VOCs of concern above analytical detection limits (Appendix E, Table 4-1). Four of those eight contained either PCE, TCE, or 1,1,1-TCA, concentrations above observed release criteria (Table 3). Two locations (CPT-50 and CPT-51) contained concentrations of PCE and/or TCE above MCL's as established by the U.S. EPA of 5 ug/L. Six CPT groundwater samples contained VOCs above SCDM benchmarks. Five locations had sample concentration that exceed the PCE benchmark of 0.67 ug/L, with the highest concentration being 22.4 ug/L (Appendix E, Table 4-1). Bromodichloromethane was detected in sample CPT-50 at a concentration 2 ug/L, which is above the SCDM benchmark of 0.56 ug/L. Chloroform was detected at location CPT-44 at a concentration of 6.1 ug/L, which is above the groundwater SCDM benchmark of 5.7 ug/L. A concentration of 218 ug/L of TCE was detected in the groundwater sample from CPT-50. This concentration suggested that a potential source area could be present near this location. Additional investigation activities were warranted in this vicinity. CPT and groundwater sampling boreholes were abandoned upon completion with a bentonite slurry mixture that was tremmied into place from the bottom of the borehole to the surface. CPT locations were surveyed by the U.S. EPA using survey grade GPS technology.

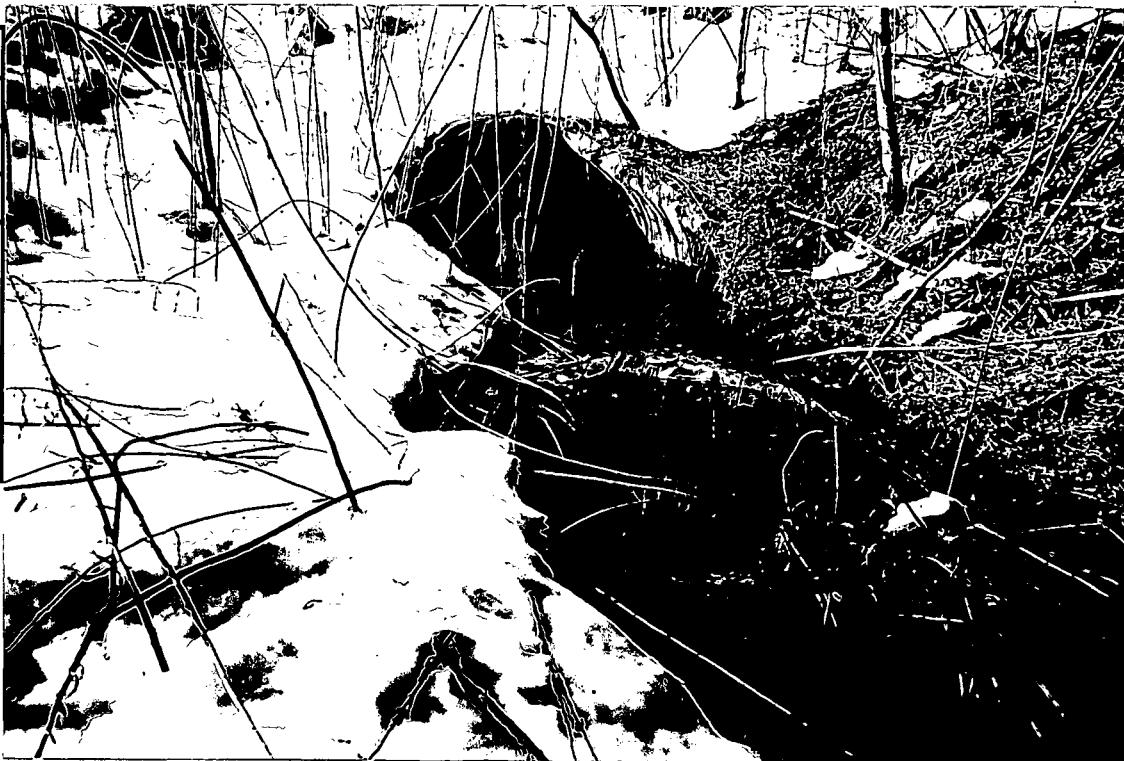
**COMMENTS:** Photo of storm water discharge at Dyna Gear, Inc. facility.

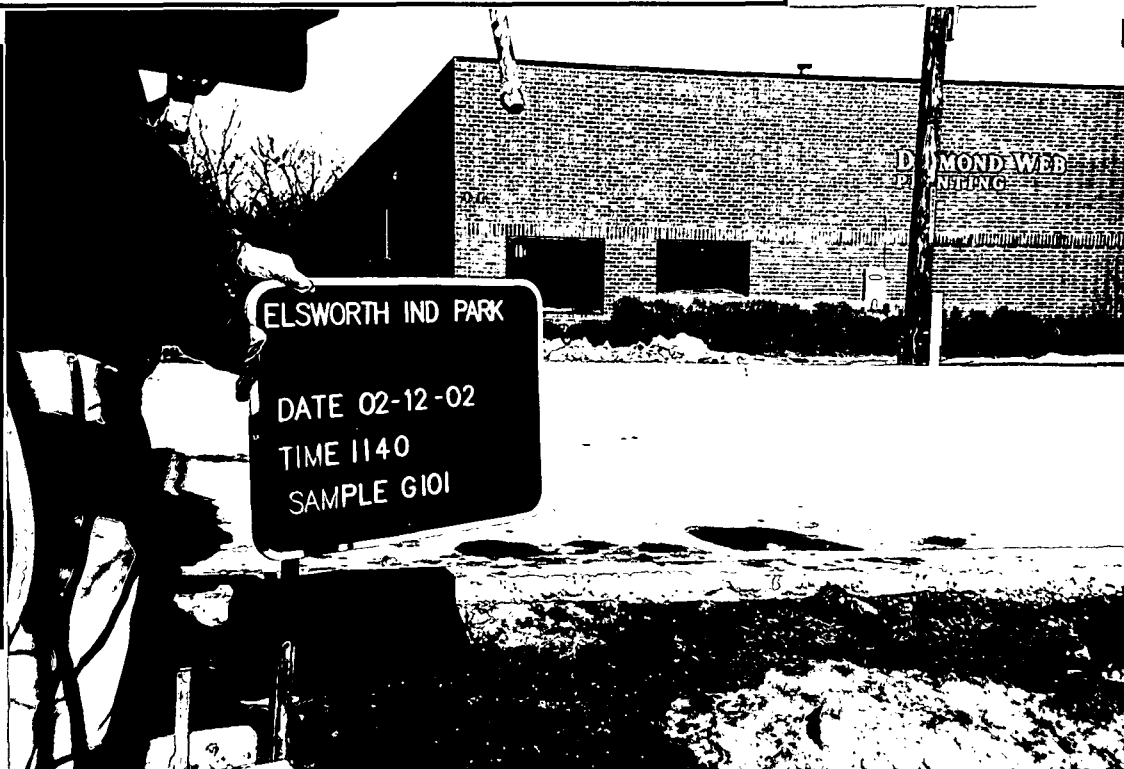
**COMMENTS:** Photo of groundwater sample location G-101, collected from probe location EIP-1. Located along south side of Hitchcock Ave.

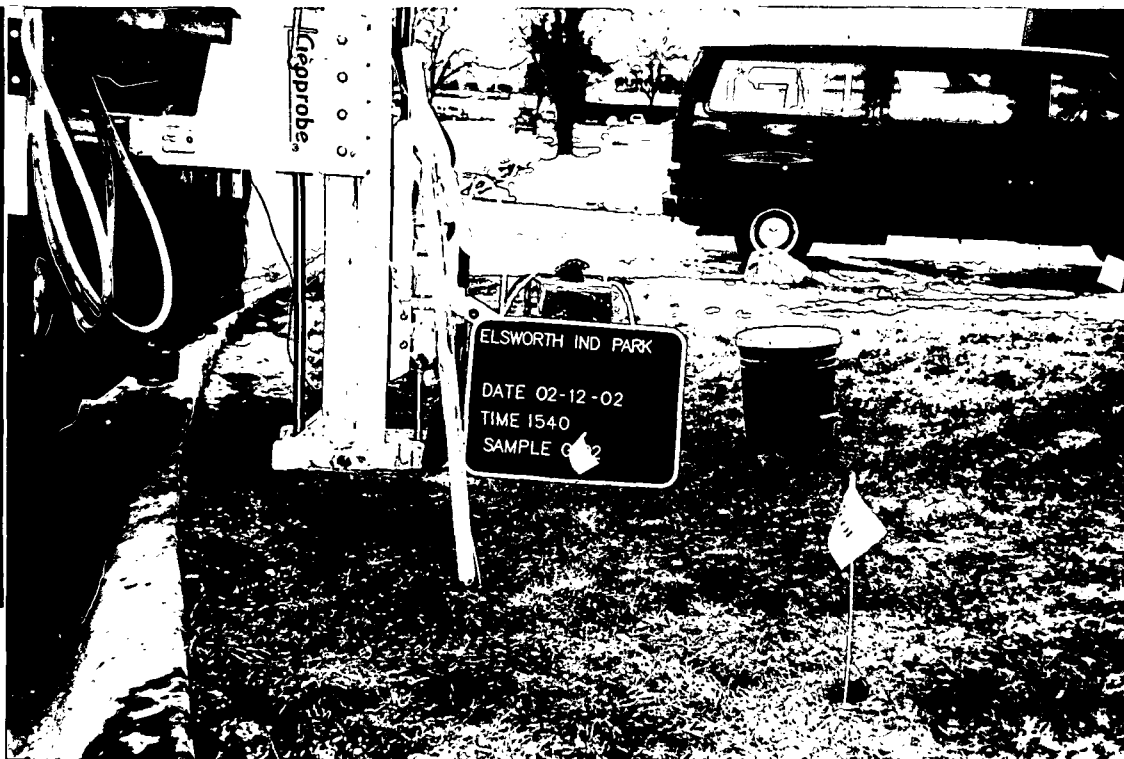
**COMMENTS:** Photo of groundwater sample location G-102, collected from probe location EIP-2. Located on the northeast corner of Janes and Inverness.

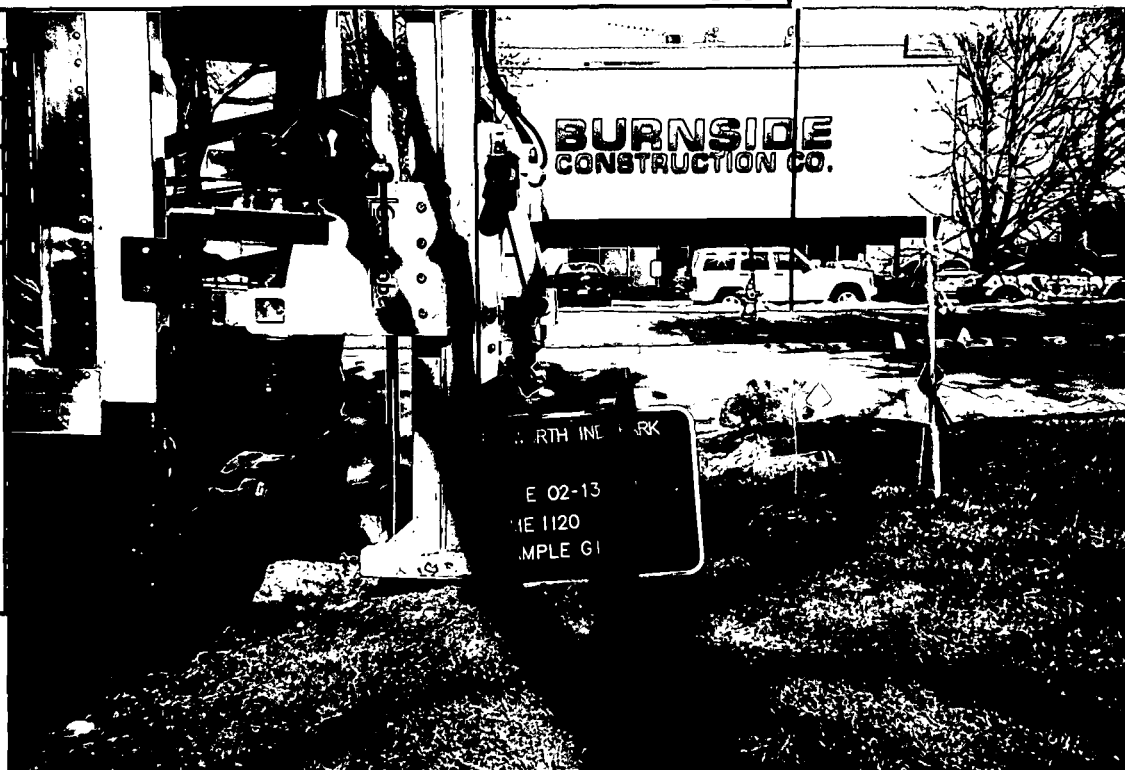
**COMMENTS:** Photo of groundwater sample location G-103, collected from probe location EIP-3. Located on the southeast corner of Janes and Wisconsin.

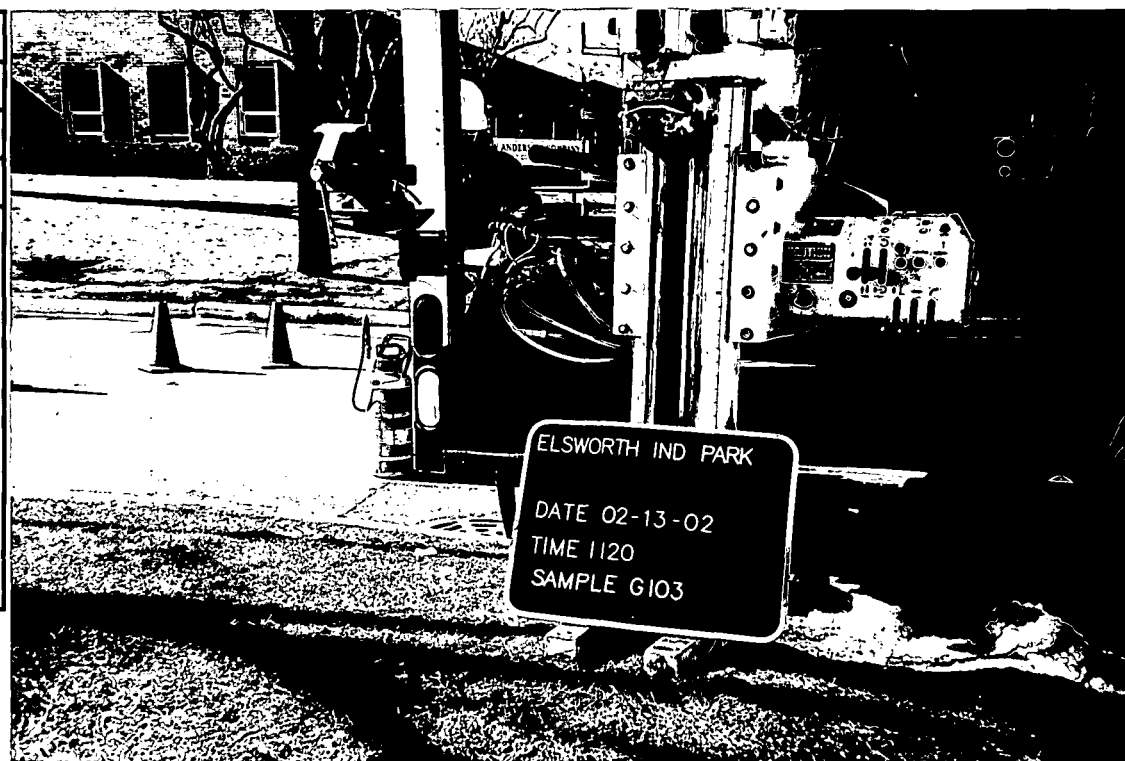
**COMMENTS:** Photo of groundwater sample location G-103, collected from probe location EIP-3. Located on the southeast corner of Janes and Wisconsin.

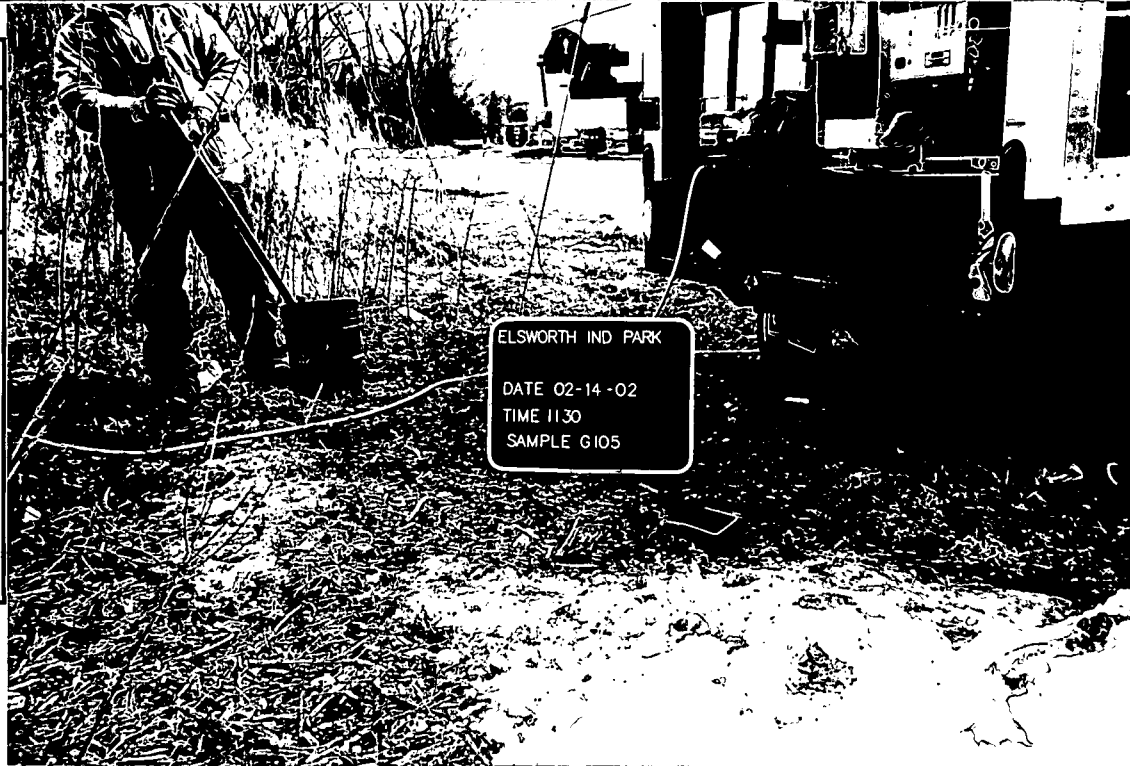
**COMMENTS:** Photo of groundwater sample location G-105, collected from probe location EIP-5. Located at the northwest corner of Dyna Gear, Inc. property next to the asphalt.

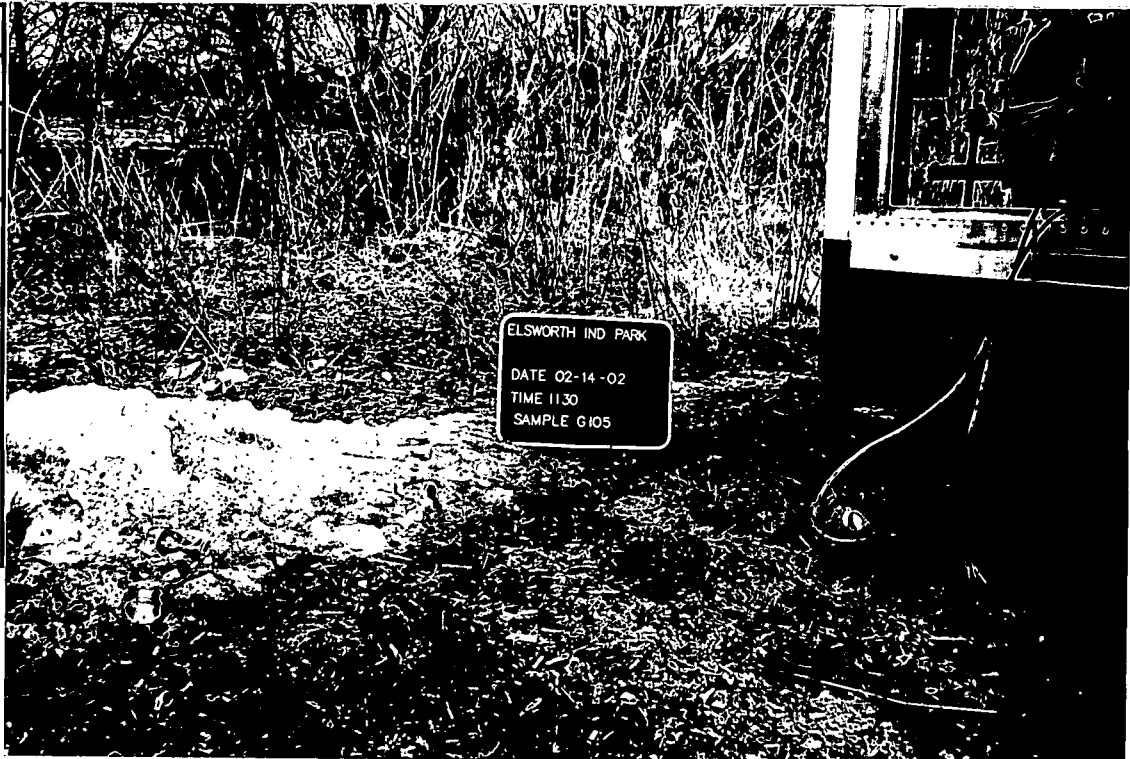
**COMMENTS:** Photo of groundwater sample location G-105, collected from probe location EIP-5. Located at the northwest corner of Dyna Gear, Inc. property next to asphalt.

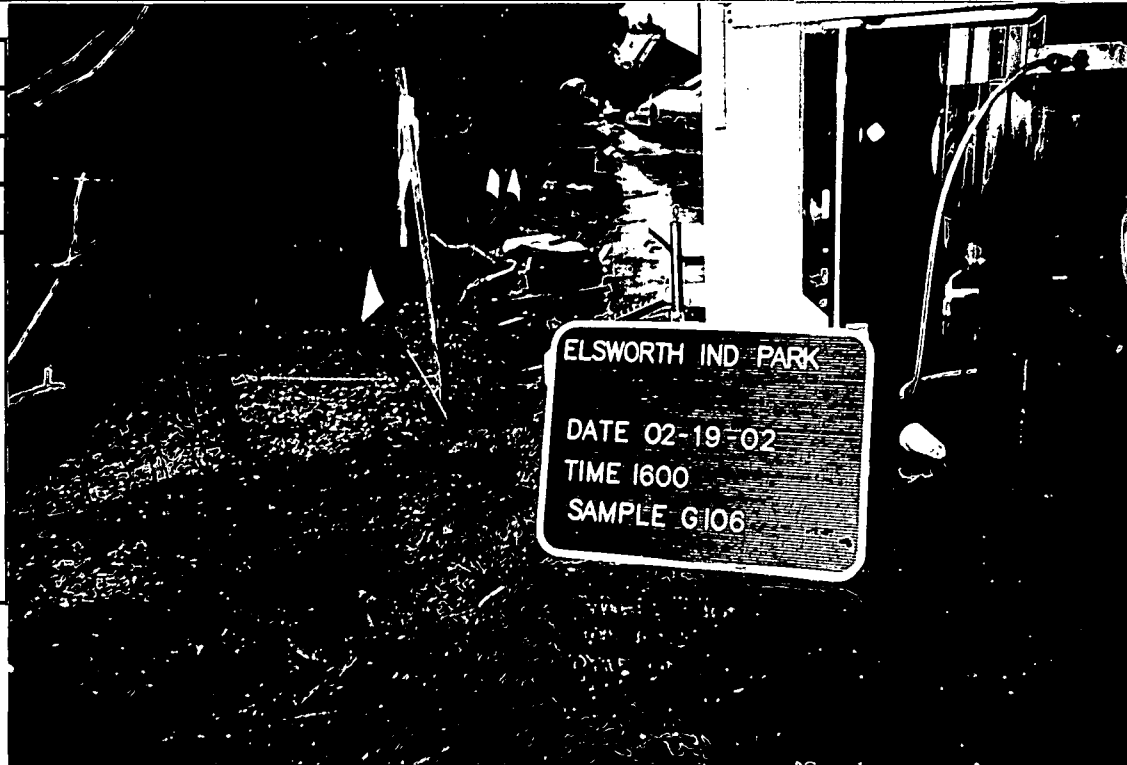
**COMMENTS:** Photo of groundwater sample location G-106, collected from probe location EIP-6. Located along the north property edge of the Dyna Gear, Inc. facility near St. Joseph Creek.

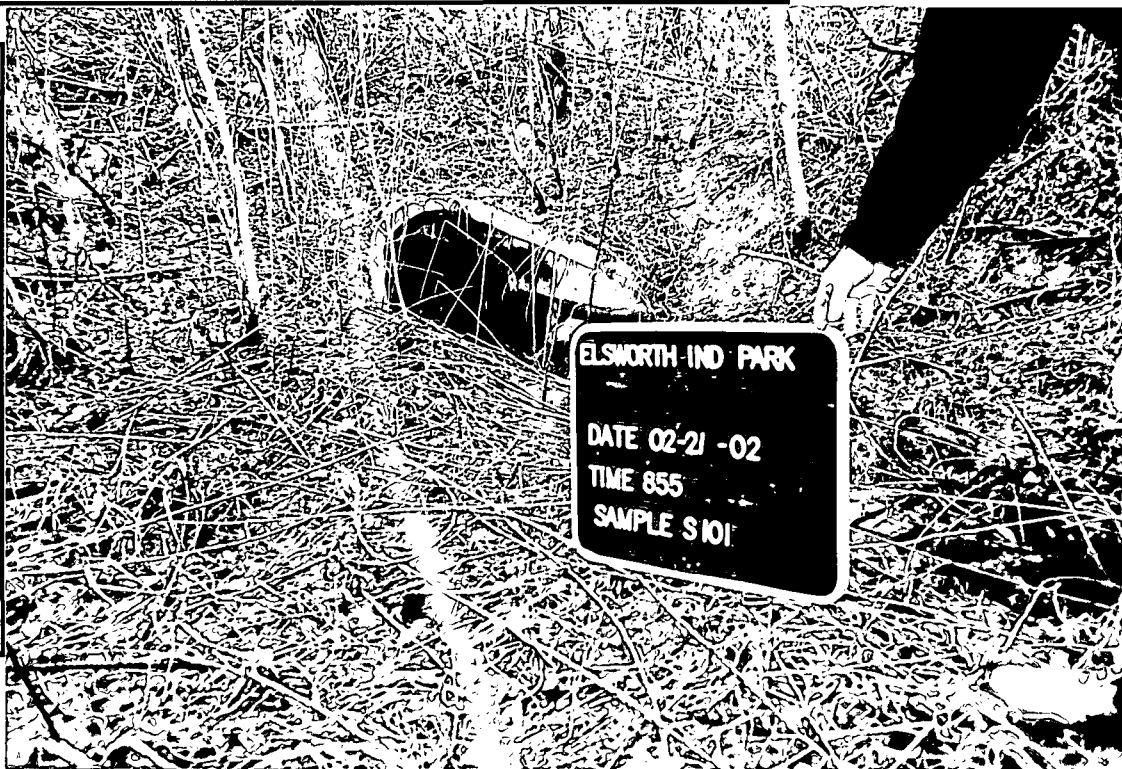
**COMMENTS:** Photo of surface water sample location S-101, located at the Dyna Gear, Inc. storm water discharge.

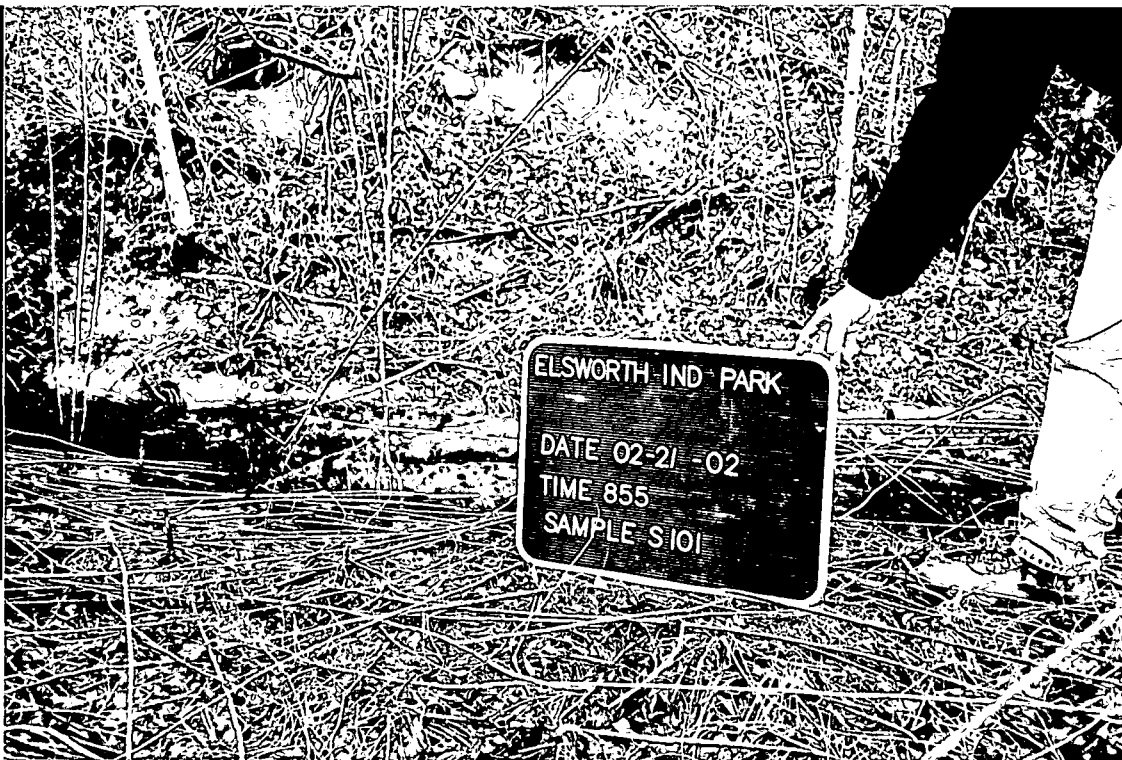
**COMMENTS:** Photo of surface water sample location S-101, located at the Dyna Gear, Inc. storm water discharge.

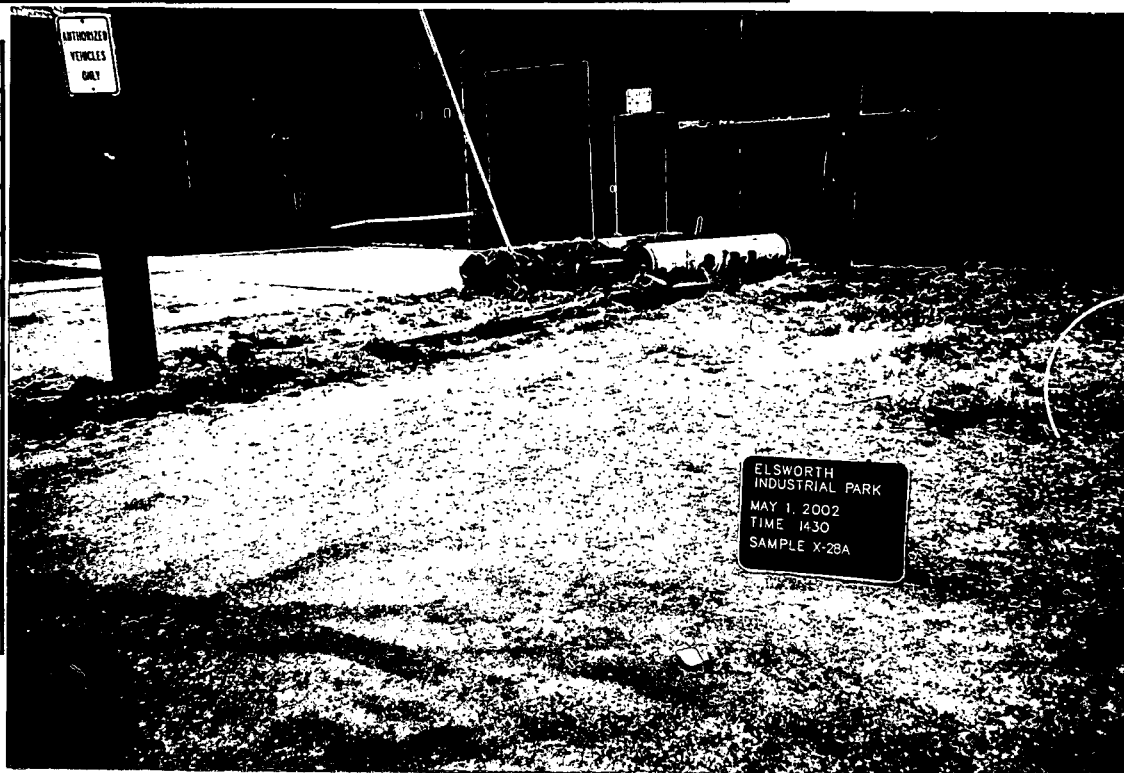
**COMMENTS:** Photo of soil sample location X-28A, collected from probe location GP-28. Located south of the Scot, Inc. facility located at 2525 Curtiss Street.

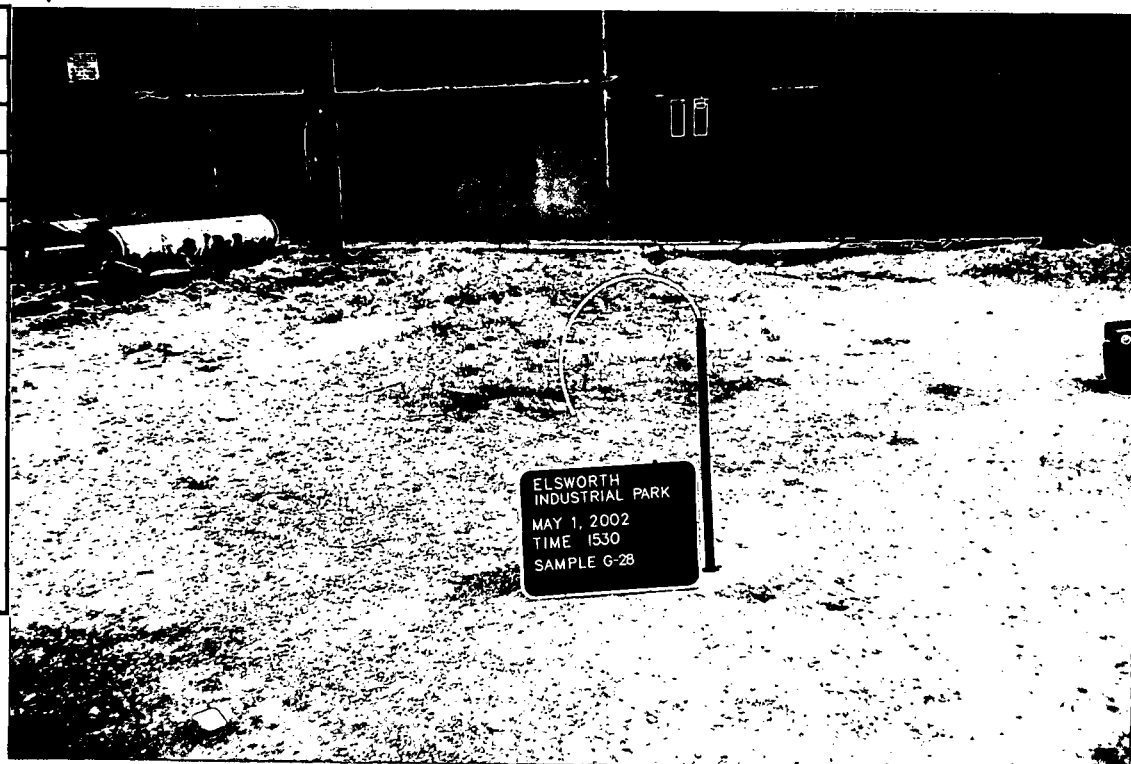
**COMMENTS:** Photo of groundwater sample location G-28, collected from probe location GP-28. Located south of the Scot, Inc. facility located at 2525 Curtiss Street.

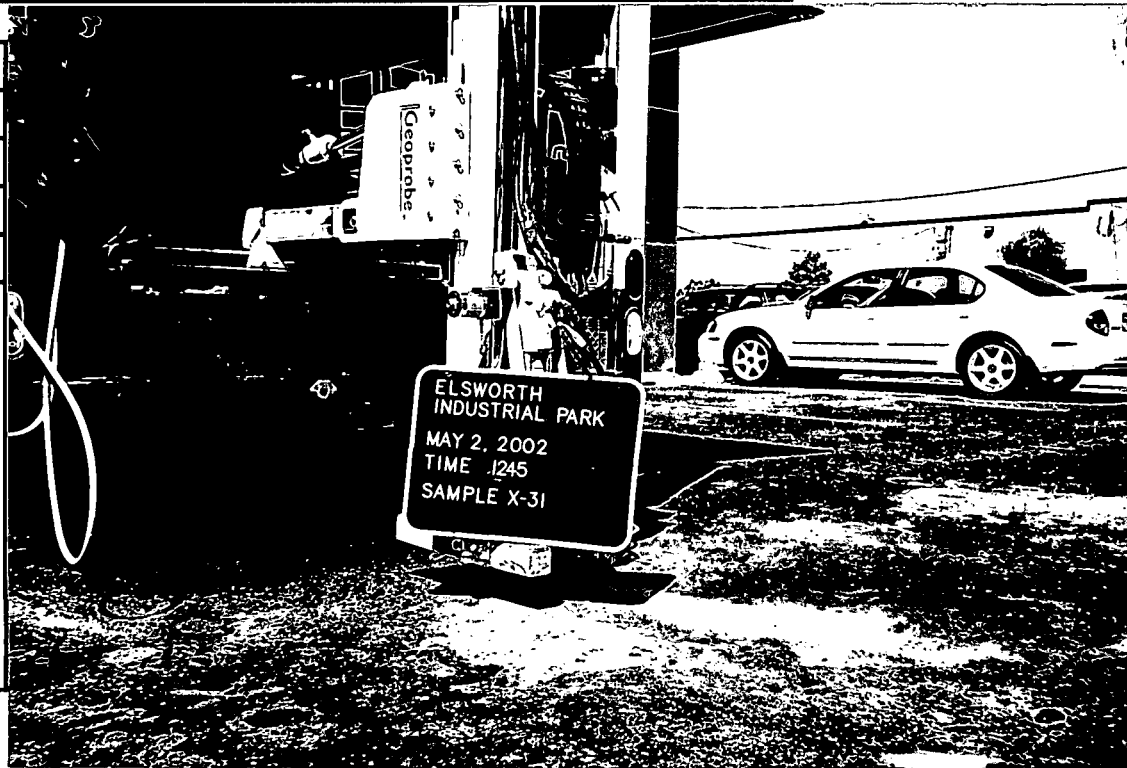
**COMMENTS:** Photo of soil sample location X-31, collected from probe location GP-31. Located south of the Scot, Inc. facility at 2525 Curtiss Street.

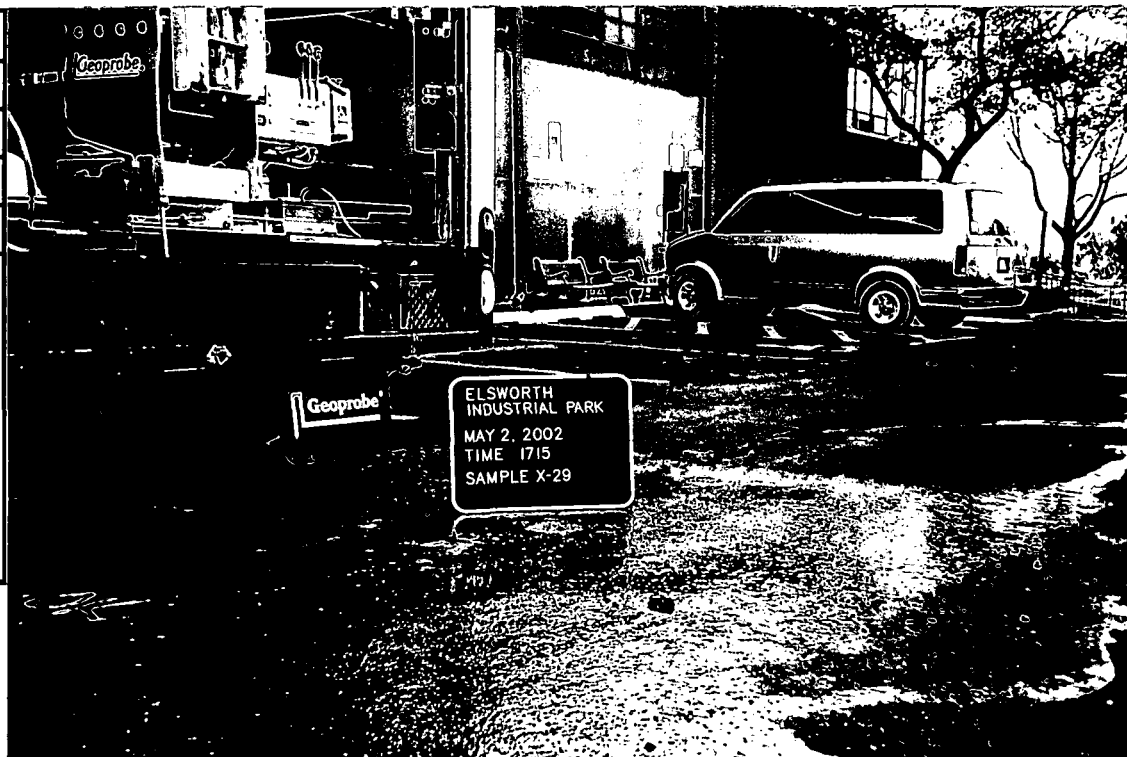
**PHOTO:** Roll 1 / Photo 9

**COMMENTS:** Photo of soil sample location X-29, collected from probe location GP-29. Located in the east parking lot at the Scot, Inc. facility located at 2525 Curtiss Street.

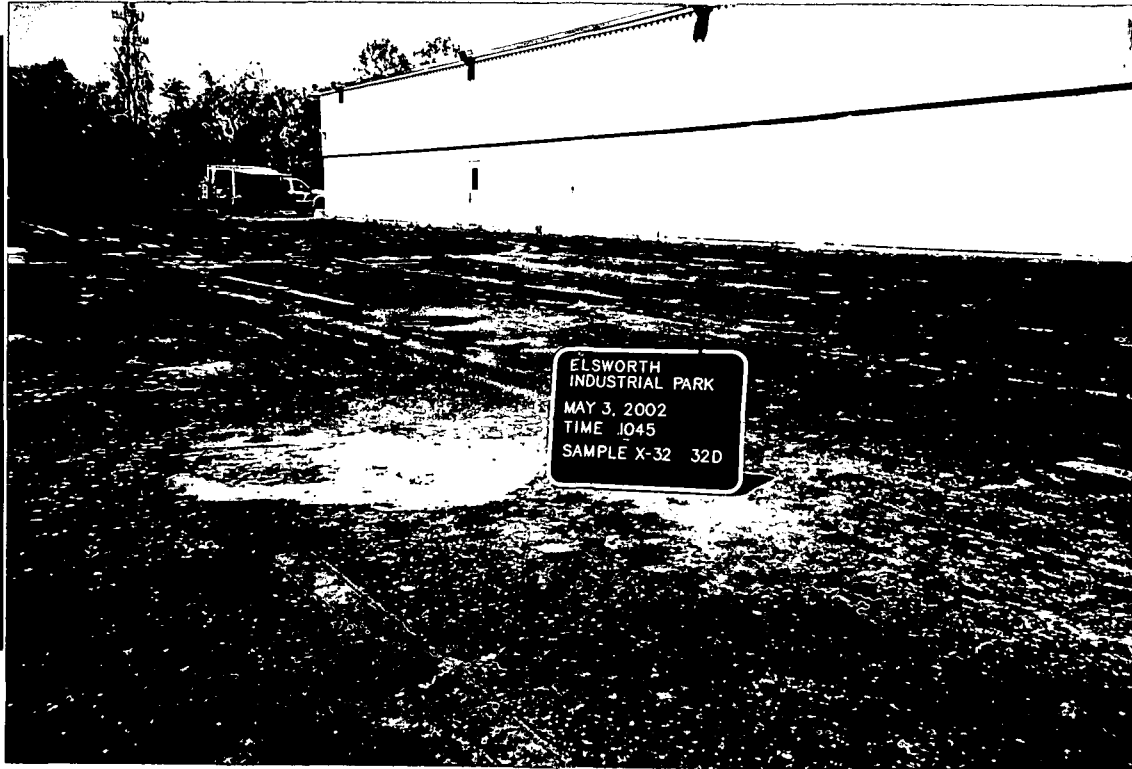
**COMMENTS:** Photo of soil sample location X-32 and X-32D, collected from probe location GP-32. Located at the east end of the south parking lot at the Ames Supply Co. property at 2537 Curtiss Street.

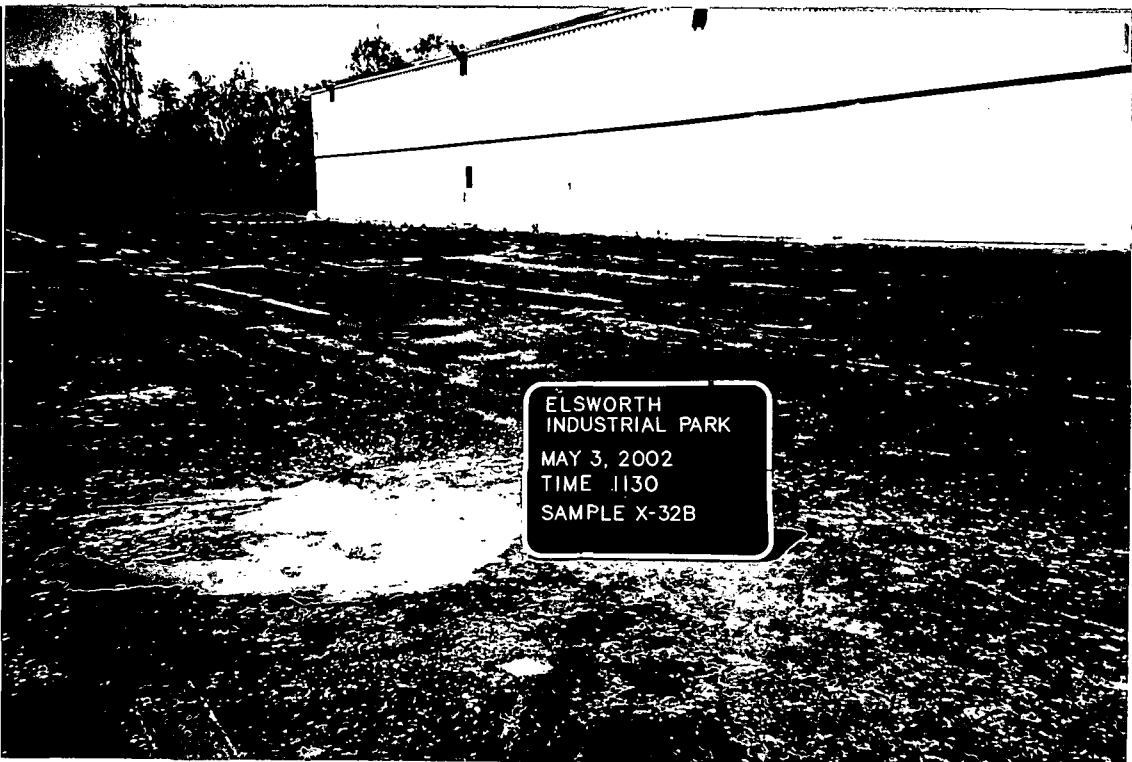
**COMMENTS:** Photo of soil sample location X-32B, collected from probe location GP-32. Located at the east end of the south parking lot at the Ames Supply Co. property at 2537 Curtiss Street.

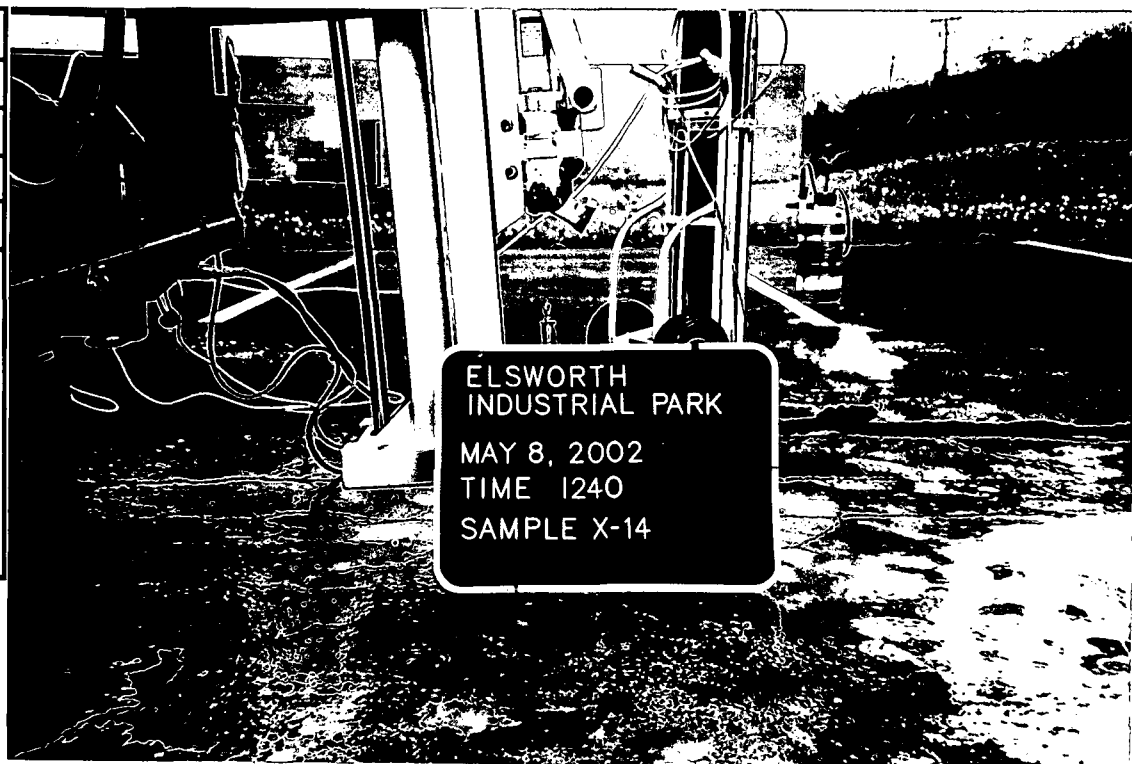
**COMMENTS:** Photo of soil sample location X-14, collected from probe location GP-14. Located at the southeast corner of the west parking area of the Arrow Gear Co. property at 2301 Curtiss Street.

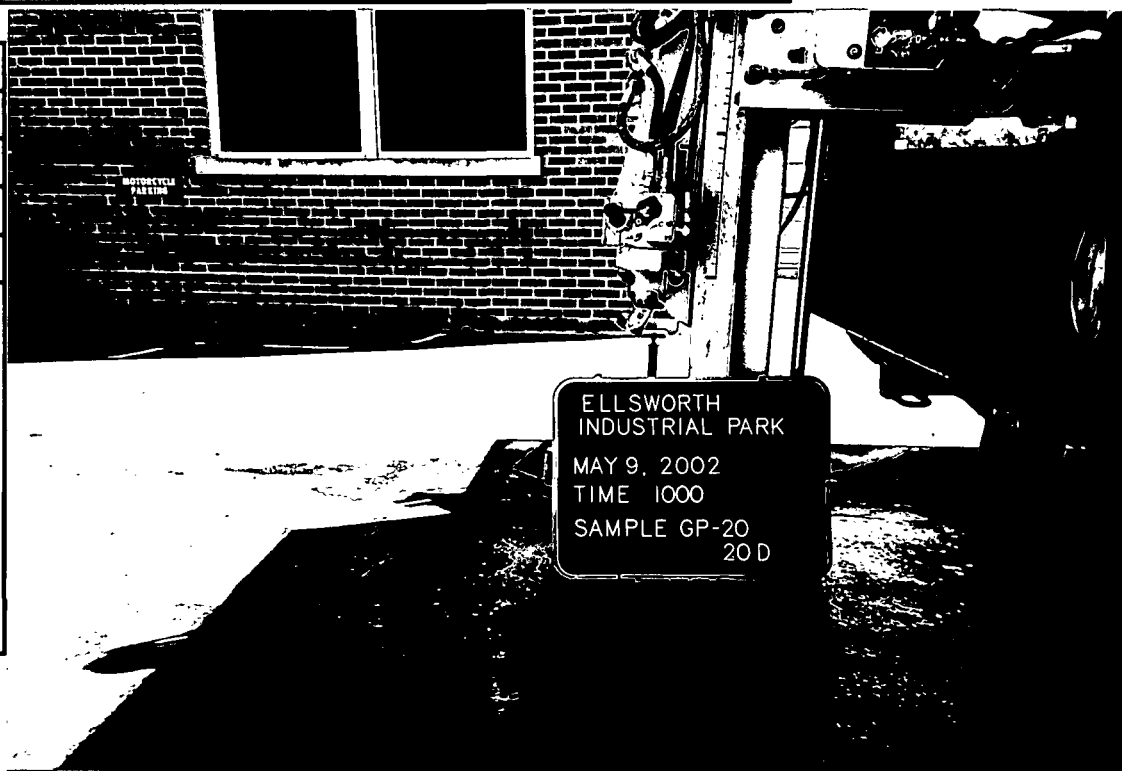
**DATE:** May 9, 2002  
**TIME:** 10:00  
**PHOTO BY:** Jim Salch  
**PHOTO:** Roll 1 / Photo 15  
**DIRECTION:** South  
**COMMENTS:** : Photo of soil sample location GP-20 and GP-20D, collected from probe location GP-20. Located at the west corner of the north parking area, at the Arrow Gear Co. property at 2301 Curtiss Street.

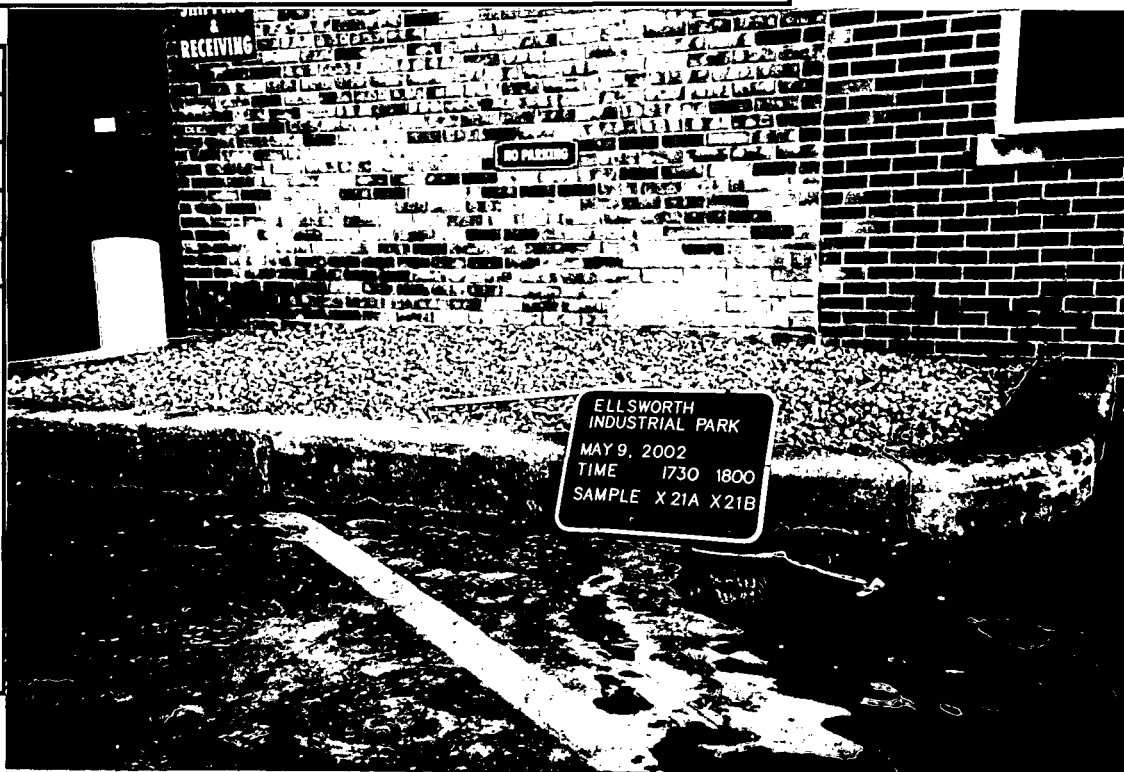
**COMMENTS:** Photo of soil sample location X-21A and X-21B, collected from probe location GP-21. Located near the loading dock at the north parking area of the Arrow Gear Co. property at 2301 Curtiss Street.

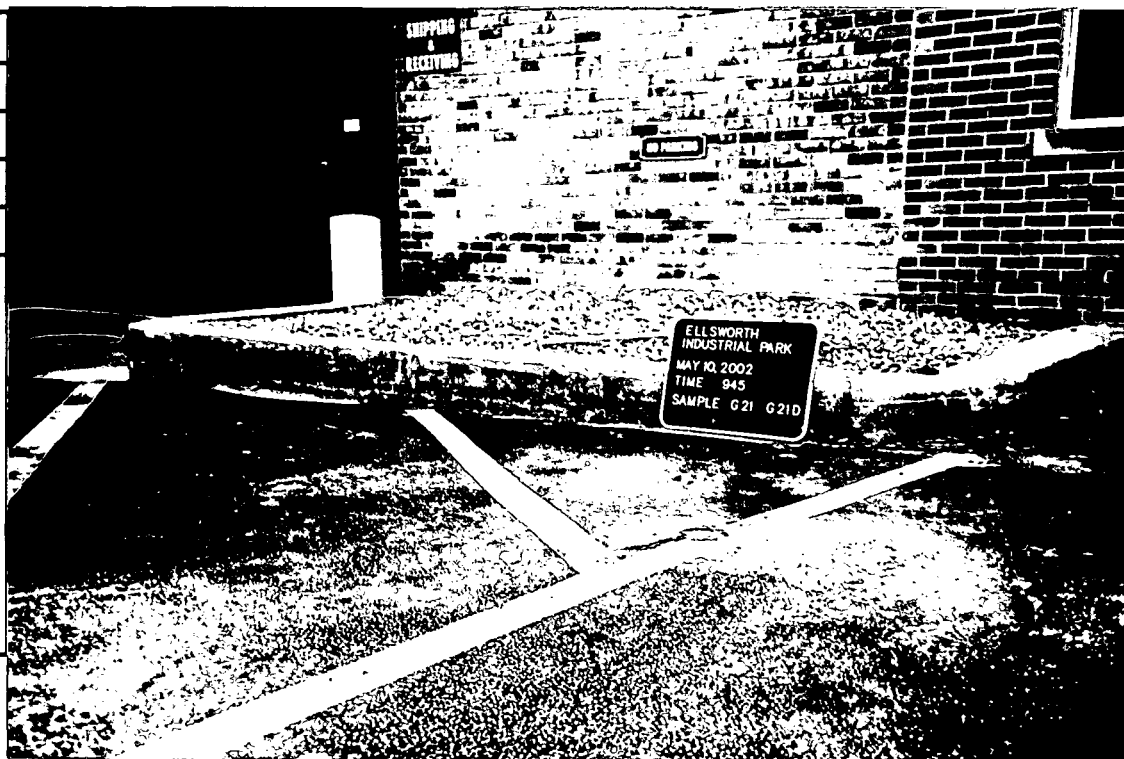
**COMMENTS:** Photo of groundwater sample location G-21 and G-21D, collected from probe location GP-21. Located near the loading dock at the north parking area of the Arrow Gear Co. property at 2301 Curtiss Street.

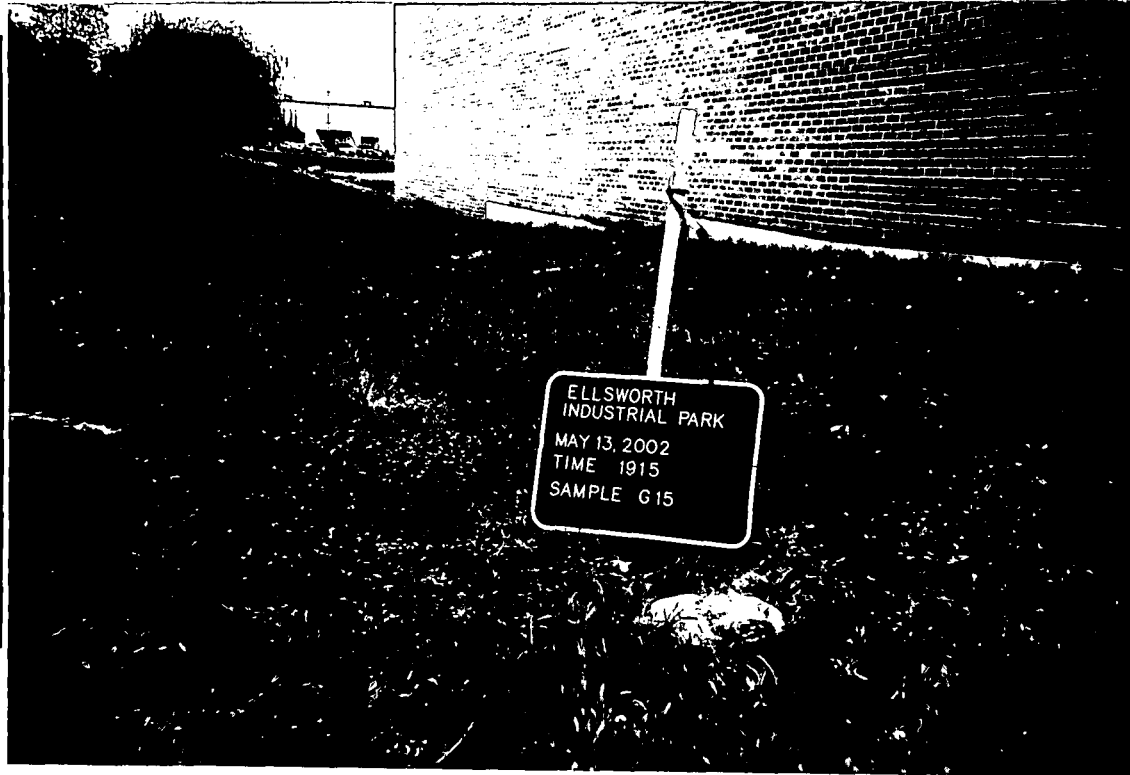
**COMMENTS:** Photo of groundwater sample location G-15, collected from probe location GP-15. Located south of the Arrow Gear Co. facility located at 2301 Curtiss Street.

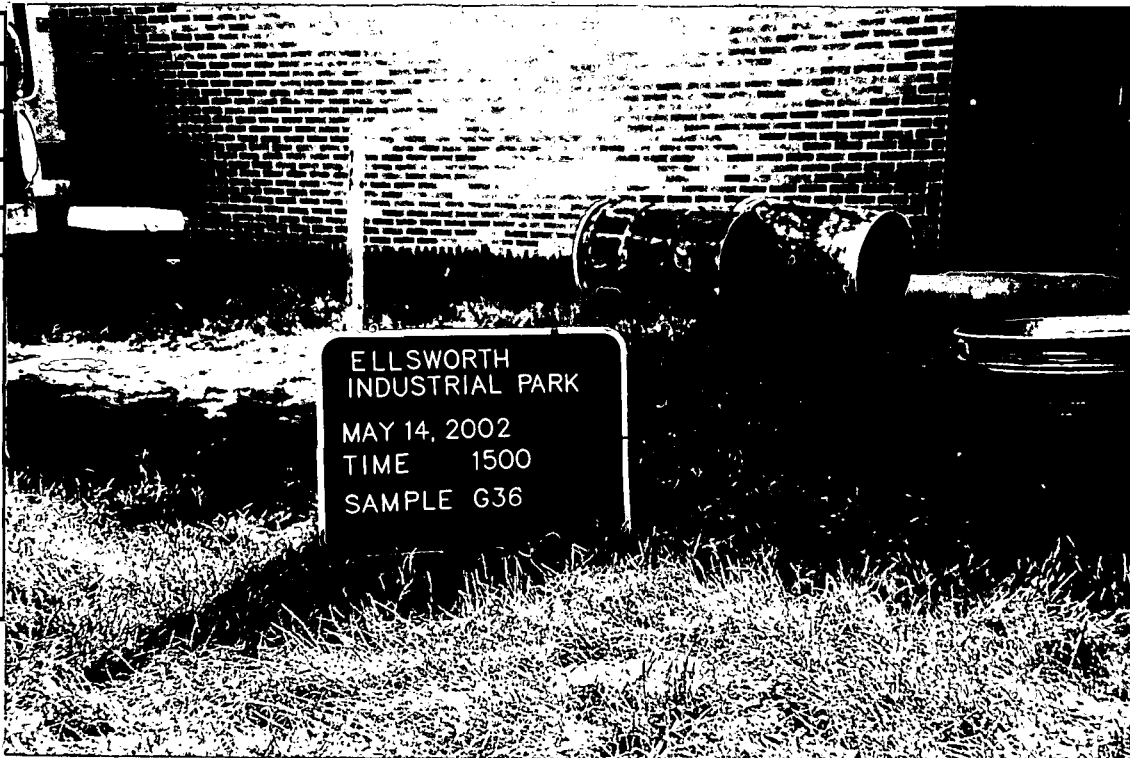
**COMMENTS:** Photo of groundwater sample location G-36, collected from probe location GP-36. Located south of the Arrow Gear Co. facility located at 2301 Curtiss Street.
